Title: Mechanical Properties of an Irradiated Inconel 718 Beam Window

Mechanical Properties of an Irradiated Inconel 718 Beam Window

Isotope Production Facility - LANSCE

Irradiation Damage and Replacement

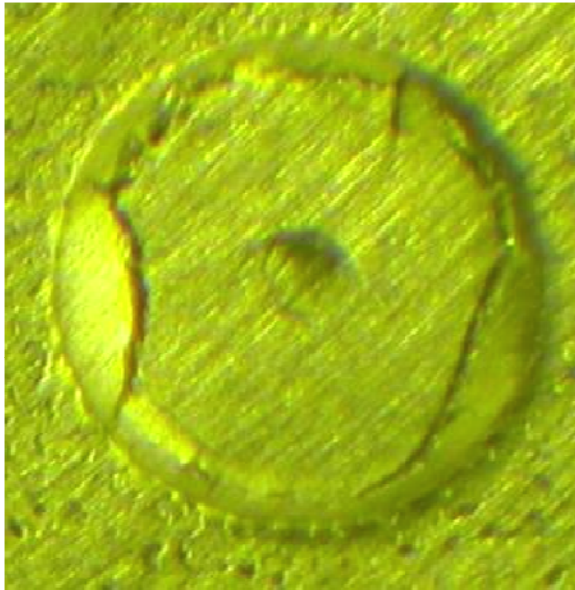
Examples of Brittle Fracture in Shear Punch

- EP-823 tested at 25C
- irradiated to 15 dpa
- $T_{irr} = 360C$

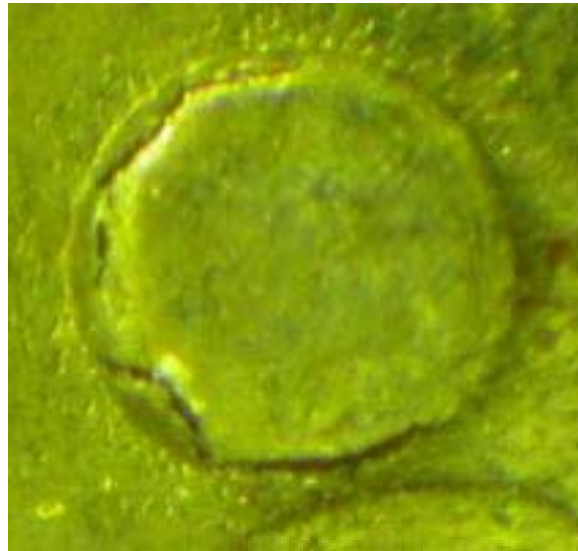
- TA-1W
- 26 dpa
- 3300 appm He

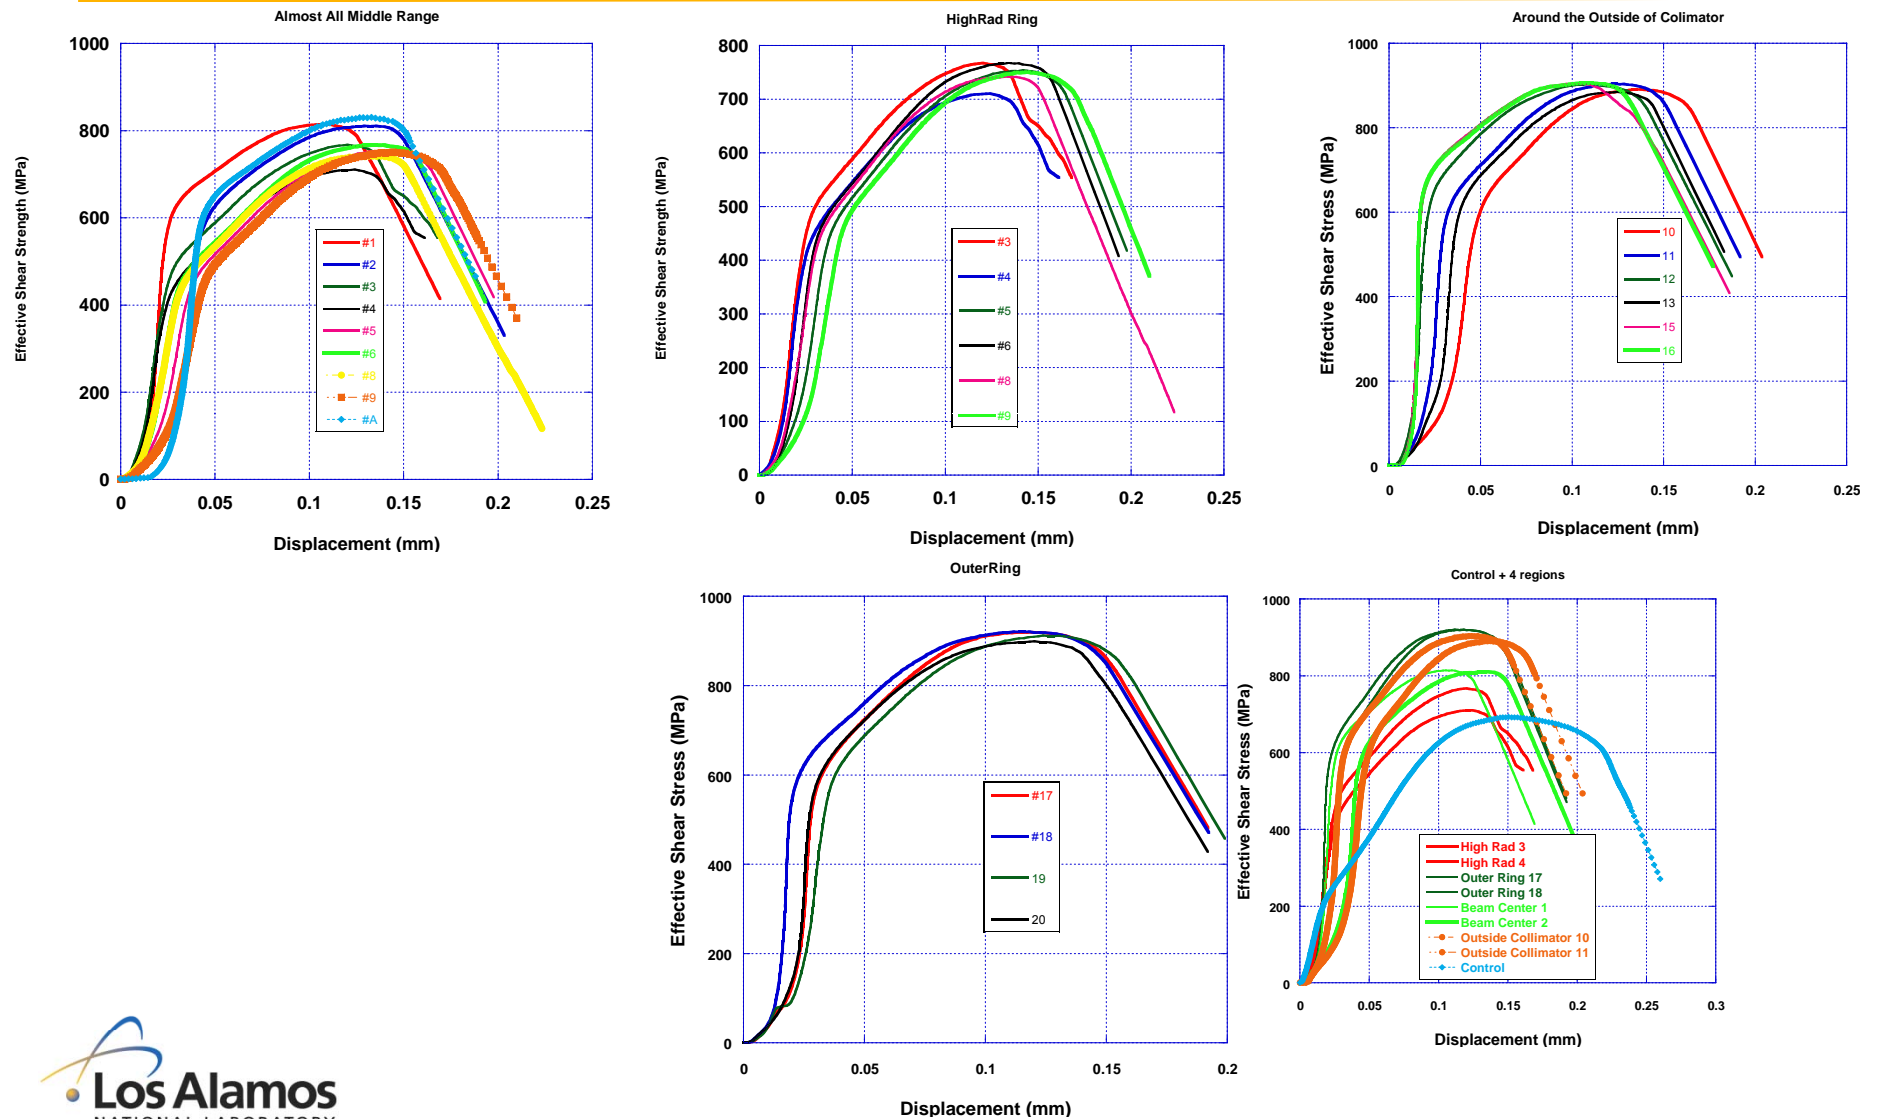
Shear Punch Results

- All samples display ductility in both yield vs UTS and optically.
- Samples taken in outer ring and outside collimator have a higher yield and UTS than control or high radiation dose samples.
 - Expected that they would be similar to the control samples.
- Shear Punch centers are being prepped for FIB and TEM to view radiation damage and initial condition.
